Technical Report CERC-96-5
September 1996

Periodic Inspection of Nawiliwili Harbor Breakwater, Kauai, Hawaii

Report 1

Base Conditions

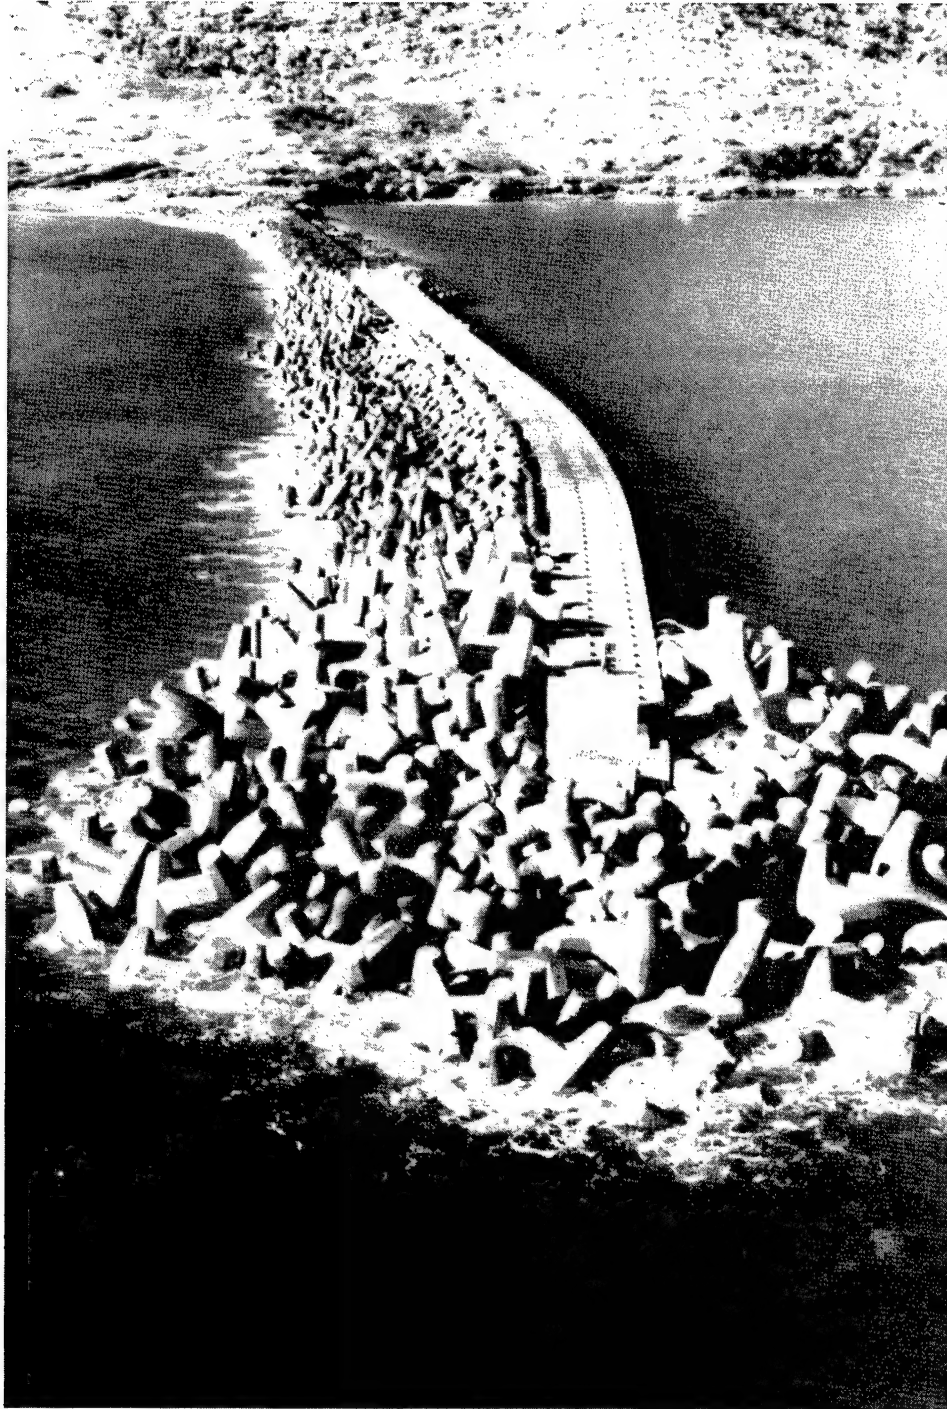
Hurricane Iniki struck the island of Kauai in 1992 with Nawiliwili almost directly in its path. Eyewitness accounts indicated that seas outside the harbor reached 10 m (33 ft) during the storm and over 3 m (10 ft) inside the harbor. Storm surge exceeded 5 m (16 ft) along much of the southern island coast. A survey revealed that three 20,865-kg (23-ton) dolosse, seven 9,980-kg (11-ton) dolosse, and six 16,150-kg (17.8-ton) tribars had broken as a result of the hurricane. A survey of the structure in 1994 revealed a total of 54 broken concrete armor units on the structure above the waterline. An aerial photo of Nawiliwili breakwater in 1995 is shown in Figure 7.

Figure 7. Aerial photograph of Nawiliwili breakwater (1995)

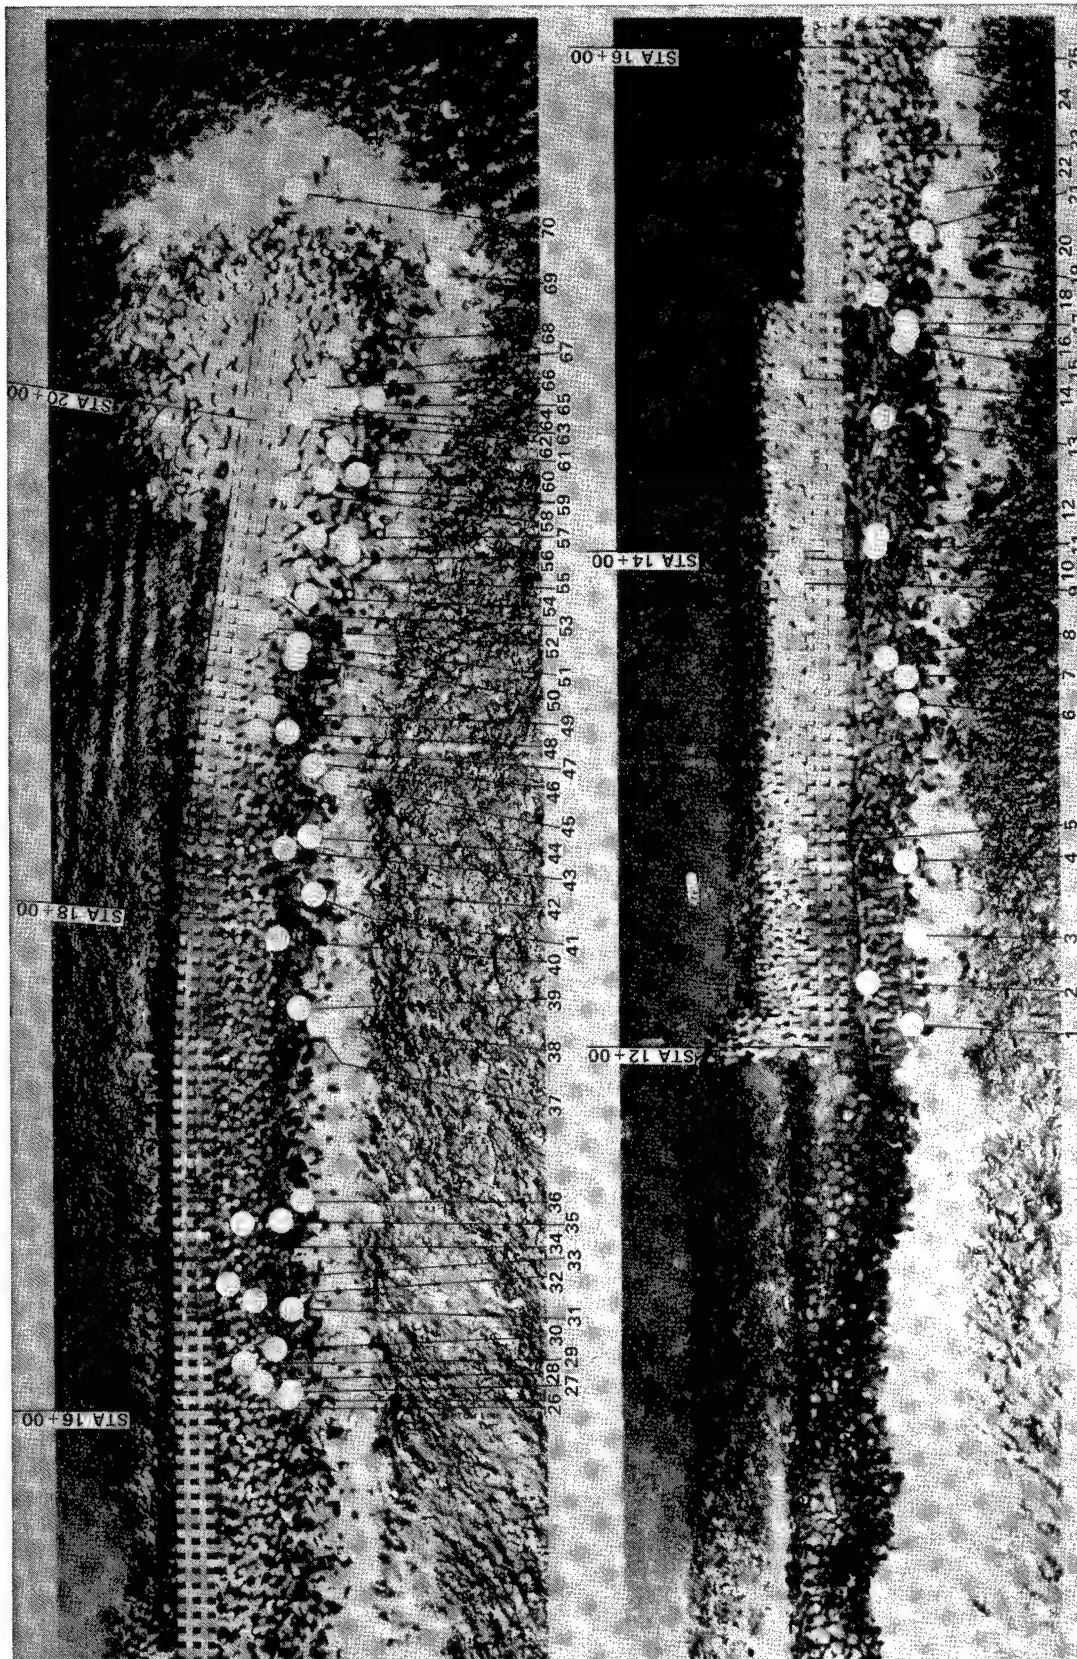
The approximate locations of broken/cracked armor units along the outer portion of the breakwater are shown in Figure 14, and detailed data obtained during the broken armor unit inventory are shown in Table 3. Armor unit numbers identified in Figure 14 correspond to those listed in Table 3. As shown, broken units occur along the entire length on the sea side of the structure, but in general, are more concentrated along the

Figure 14. Approximate locations of broken/cracked armor units along outer portion of Nawiliwili Harbor breakwater

seaward end of the breakwater. Sixty-one percent of the broken units are located on the outer half of the structure (sta 16+00 - 20+50), and about one third of the broken units are situated on the outer 45.7-m (150-ft) length of the breakwater (sta 19+00 - 20+50). With regard to distance from baseline, the majority of broken units (71 percent) are located between 7.6 and 16.8 m (25 and 55 ft) seaward of the baseline. These units are in the active wave zone.

Of the 70 broken or cracked armor units, 39 were 9,980-kg (11-ton) dolosse, 19 were 16,150-kg (17.8-ton) tribars, 8 were 20,865-kg (23-ton) dolosse, and 4 were 5,900-kg (6.5-ton) tribars. Considering the types of breaks, 54 percent (21 units) of the 9,980-kg (11-ton) dolosse and 63 percent (5 units) of the 20,865-kg (23-ton) dolosse were determined to be mid-shank breaks. Of all the dolosse breaks recorded, 77 percent were straight and 23 percent were angled. Of the 19 broken 16,150-kg (17.8-ton) tribars, 14 (74 percent) consisted of one leg broken off through the center of the unit. The four broken 5,900-kg (6.5-ton) tribars on the harbor side of the breakwater appeared to have been placed in that condition. They seemed to have been fitted on the crest adjacent to the rib cap. The detailed data obtained during the broken armor unit survey will allow for an accurate indication of new breaks when the structure is revisited at some point in the future.

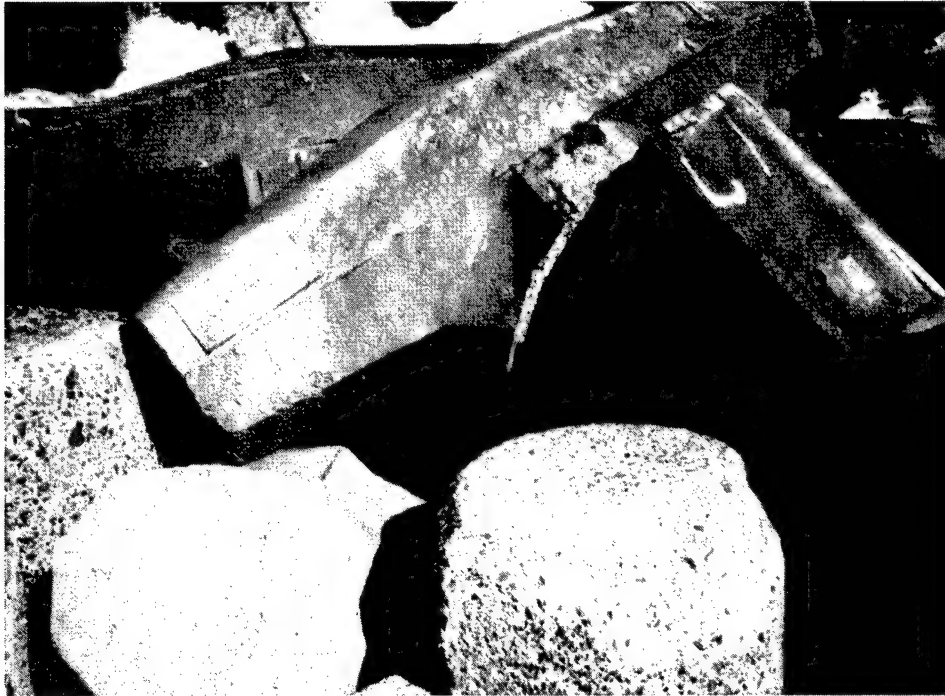
Types of breaks for the dolosse included shank and fluke breaks. These were characterized as mid-shank, shank-fluke (shank broken in vicinity of fluke), and fluke-shank (fluke broken off at junction with shank). Also recorded were straight breaks (broken straight across) and angled breaks (broken at some angle to the dolos limb). For the tribars, types of breaks included those through the center section of the unit where one or more legs were separated from the unit, and those in which just a portion of one of the legs was broken off. Views of representative types of breaks for the armor units are shown in Figures 15-18. Armor units with hairline cracks on one side were not counted; only those that were cracked all the way through were considered a break for recording purposes.

Figure 17. Dolos with shank-fluke break

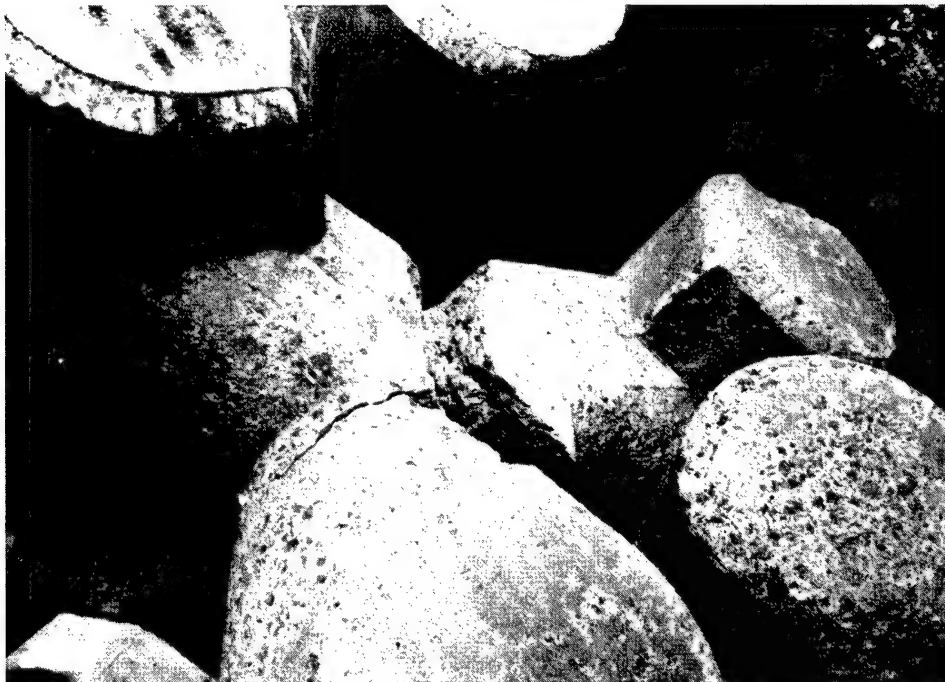
Figure 18. Tribar with break through center section of unit
